**INITIAL SITE CHARACTERIZATION
AND
SUBSURFACE INVESTIGATION REPORT**

**4TH AND GAMBELL
ANCHORAGE, ALASKA**

4th & Gambell Site Investigation - DRAFT

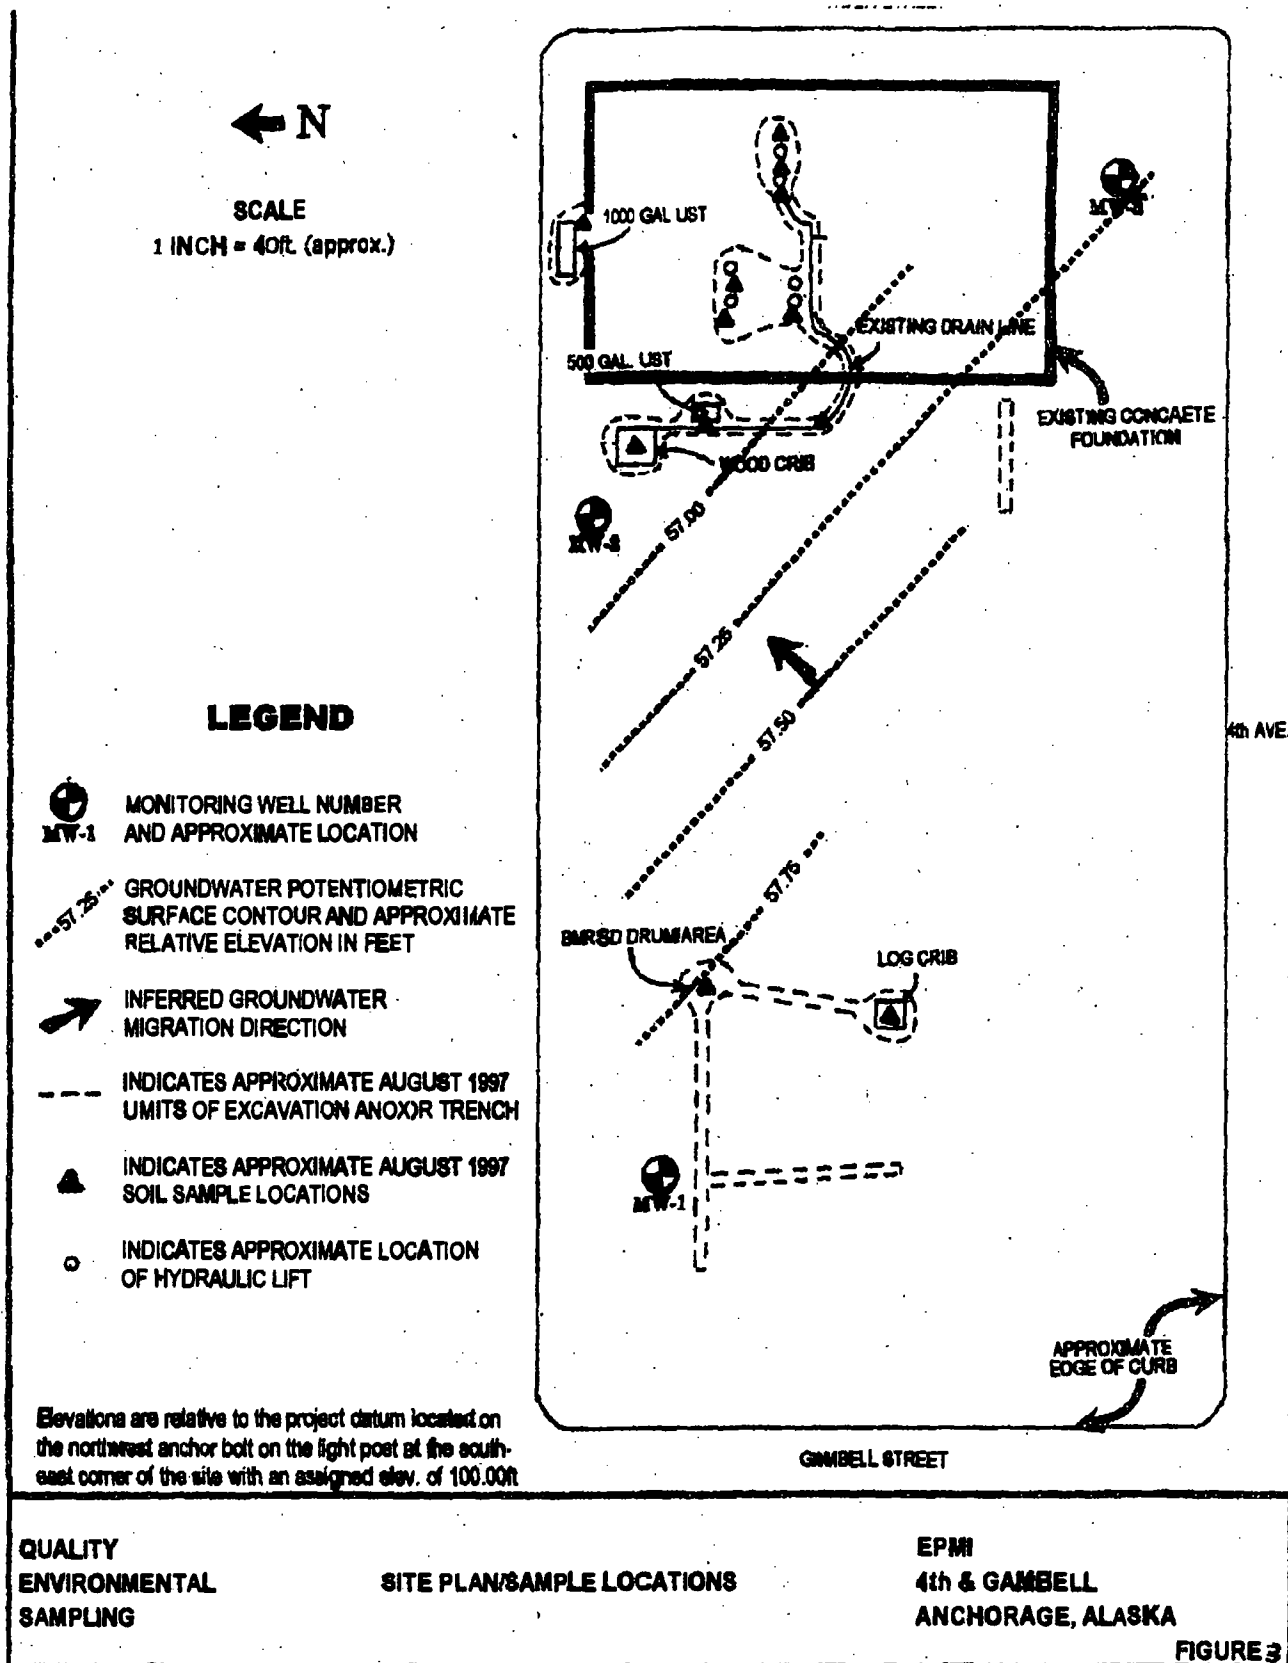
FIGURE 2

Soil sample S-7 was collected and field screened using a PID. The sample was collected beneath the 500 gallon tank at approximately 7 feet below ground surface. The location of the sample is shown in Figure 2. The depth of the sample and the corresponding PID reading is also recorded on

Soil sample S-11 was collected and field screened using a PID. The sample was collected beneath the 500 gallon tank at approximately 9 feet below ground surface. The location of the sample is shown in Figure 2. The depth of the sample and the corresponding PID reading is also recorded on the Figure. The sample was analyzed by Wy'East Environmental Sciences of Portland, Oregon. Sample S-11 was tested for diesel range petroleum hydrocarbons. The laboratory did not detect any diesel range petroleum hydrocarbons in this sample.

Using the historical information from Public Works, and the aerial photographs, EPMI began excavating in the area where the dry cleaning facility was thought to have been located. Three trenches were excavated across the location. Figure 2 shows the location of excavation activities. EPMI did not observe any suspect material in the west trench which was excavated north and south. The trench perpendicular to this trench uncovered four empty drums. The drums were marked by the manufacturer for use in dry cleaning. One sample was collected, field screened, and sent to the laboratory for analysis.

Soil sample S-5 was collected and field screened using a PID. The sample was collected in the area where the four drums were discovered at approximately 7 feet below ground surface. The location of the sample is shown in Figure 2. The depth of the sample and the corresponding PID reading is also recorded on the Figure. The sample was analyzed by Wy'East Environmental Sciences of Portland, Oregon. Sample S-5 was tested by Wy'East for VOCs by EPA Method 8260. The solvent Tetrachloroethylene, commonly used by dry cleaning facilities, was the only compound detected.

Soil sample S-6 was collected approximately 12 feet below ground surface. Soil sample S-6 was collected and field screened using a PID. The location of the sample are shown in Figure 2. The depth of the sample and the corresponding PID reading is also recorded on the Figure. The sample was analyzed by Wy'East Environmental Sciences of Portland, Oregon. Sample S-6 was tested by Wy'East for VOCs by EPA Method 8260 and for metals. The solvent Tetrachloroethylene used by dry cleaning facilities was detected as well as metal contamination.
